# Technical Supplement 14A

## Soil Properties and Special Geotechnical Problems Related to Stream Stabilization Projects

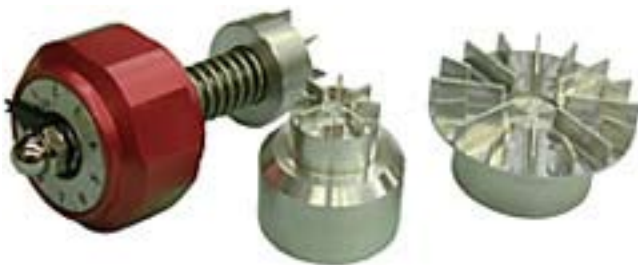
**Figure TS14A-1** Hand held torvane device (*Photo courtesy Geotest Instruments, Inc.*)

The saturated consistency of fine-grained soils with significant plasticity (plasticity index greater than about 7) correlates well with the soils' undrained shear strength. Saturated undrained strength of plastic fine-grained soils may be estimated with a field torvane device such as the one shown in figure TS14A-1 or from the descriptions provided in table TS14A-2.

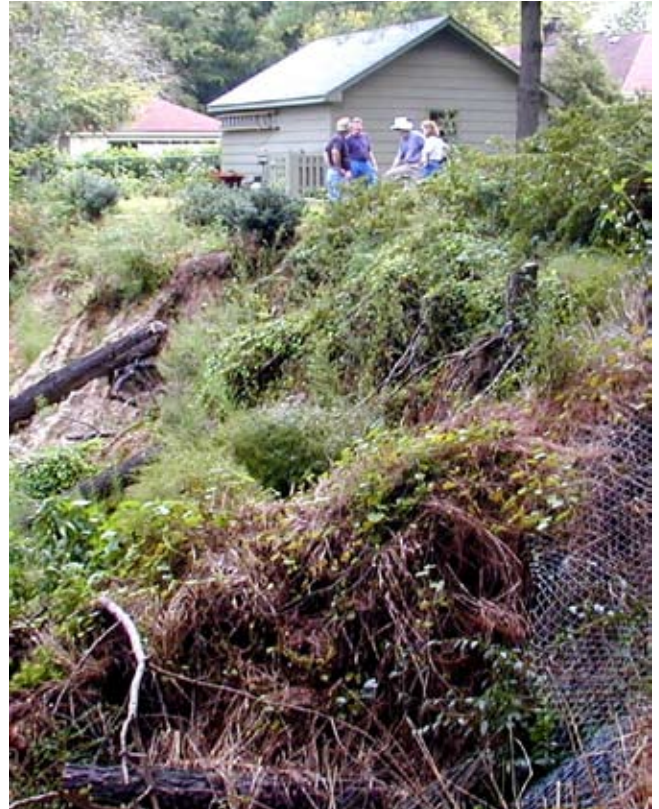
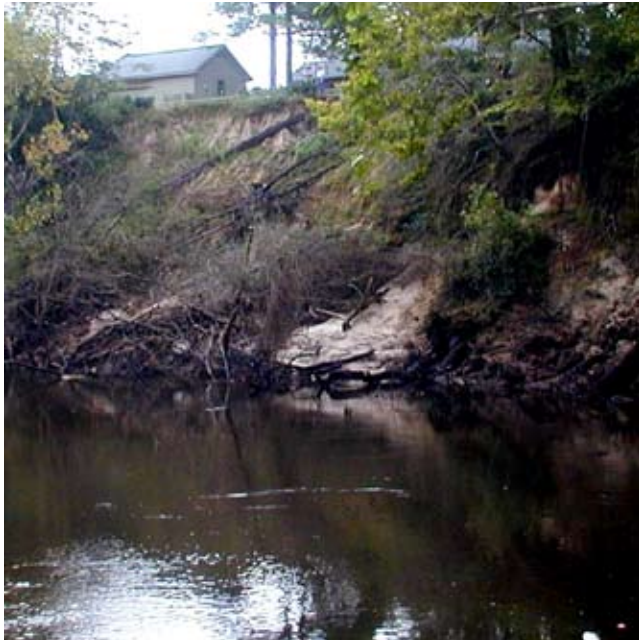
**Figure TS14A-4** Failed streambank in Tarboro, NC, following high channel flows following Hurricane Floyd. Erosion of the toe caused bank instability in the slope. Measures to protect the toe of the slope are essential, in addition to assuring stability of the system.

Figure TS14A-4 shows a slope where erosion of the toe has caused slope instability. In figure TS14A-4(a), the overall slope is seen with erosion that occurred at the toe of the slope following a large runoff event. Figure TS14A-4(b) shows the effect of the slope failure at the top of the slope, and figure TS14A-4(c) shows the middle of the failed slope area. Other ways that slope geometry or conditions may change, resulting in instability, include:

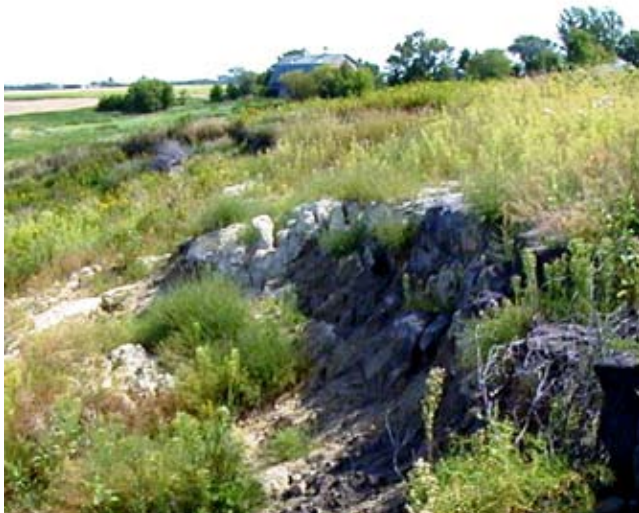
**Figure TS14A-5** Shallow sloughing failure in zone of saturated sand

Figure TS14A-5 shows a shallow slide occurring from a zone of saturated sand sloughing from seepage forces. Figure TS14A-6 shows the results of a deep-seated rotational failure in clayey soils. A later section in the document describes this type of failure in detail.

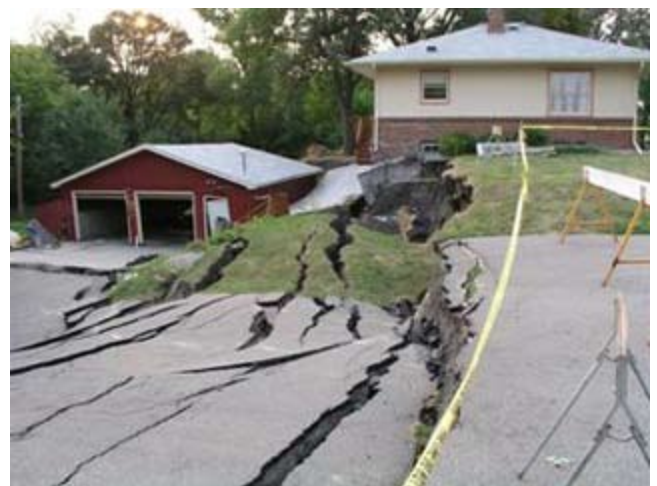
**Figure TS14A-6** Typical slope stability failure in clay soil type. Failure is a low-radius, deep rotational failure. (Photo credit City of Fargo, ND)

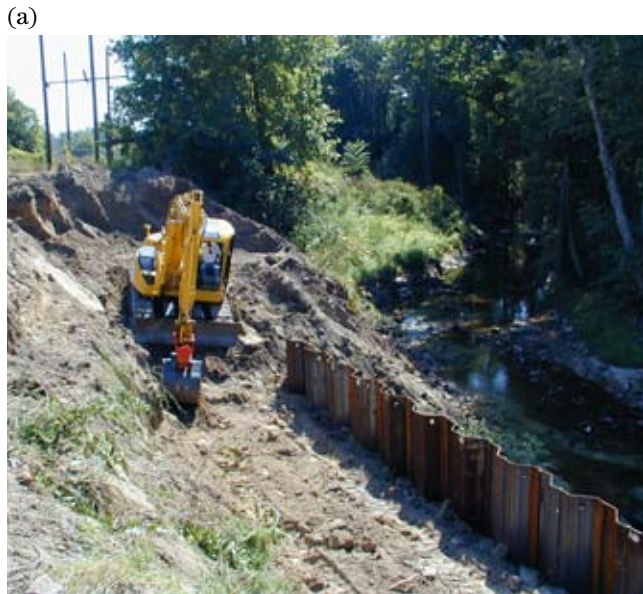
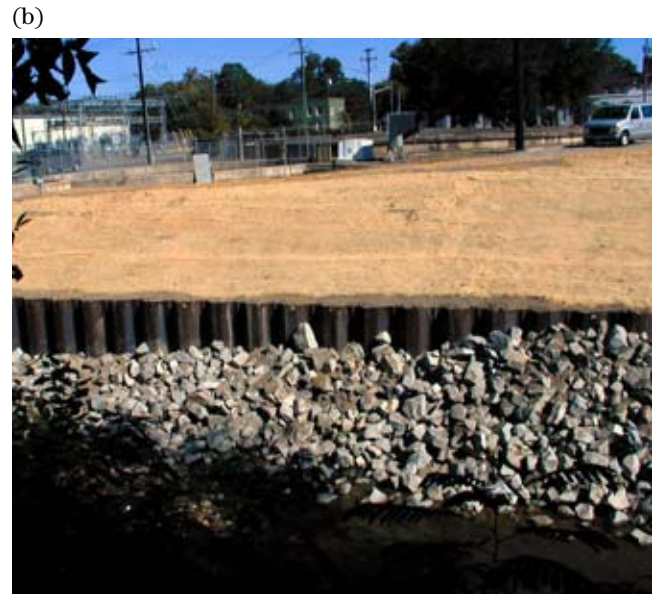
**Figure TS14A-11** Sheet pile wall at toe of slope in Tarboro, NC. Vegetation will be established above wall. Note erosion control fabric.

Figure TS14A-11 shows a project where the toe of the slope was protected using both riprap and a sheet pile wall. In many circumstances, rigid boundary constraints, improvements, or other obstacles at the top of the slope do not allow the slope to be flattened. Consequently, constructing a vertical feature at the toe of the slope may be needed.

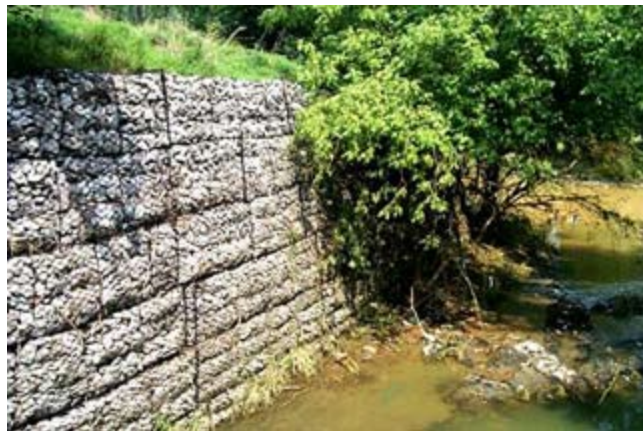
**Figure TS14A-12** Gabion wall constructed at toe of slope enabled reconstruction of failed slope where right-of-way limitations prevented flattening of the upper slope and use of other conventional toe protection measures at the toe

Another way of reconstructing a slope where limited right of way occurs is the use of gabion baskets to protect the toe of the slope (fig. TS14A-12).

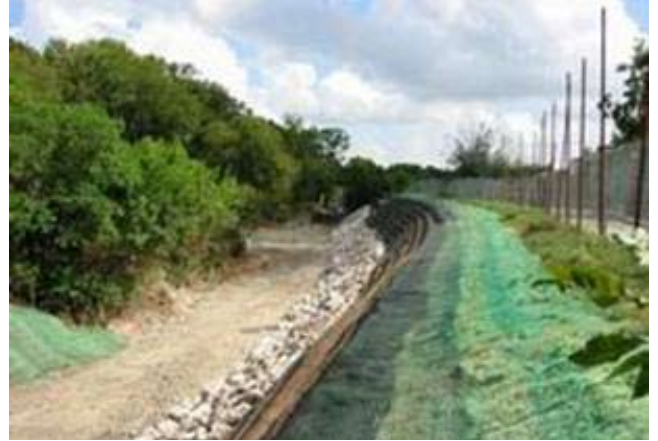
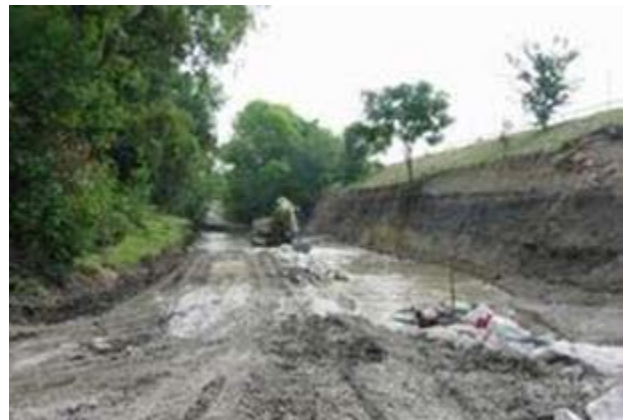
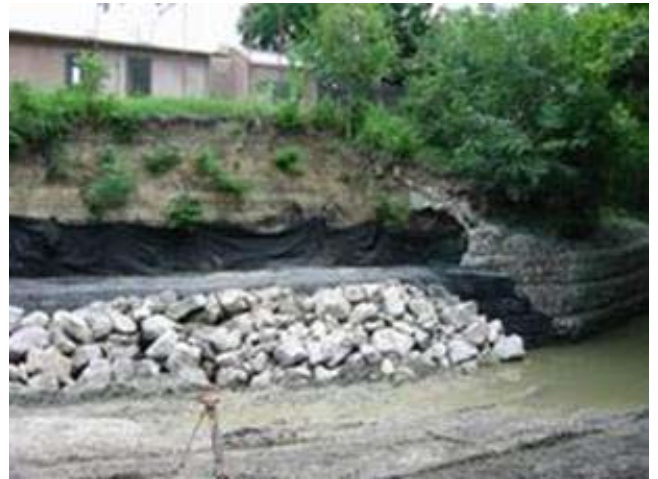
**Figure TS14A-15** Other slope stabilization projects

allows vegetation to grow and mask the construction. Geocells allow very steep slopes to be used in the reconstruction. These six photographs show a project to stabilize unstable streambanks at the Shoal Creek Project, City of Austin, Texas (fig. TS14A–15).

Figure TS14A–15 shows other slope stabilization projects where reinforced fill protected by rock armor riprap placed at the toe of the slope were employed. Figure TS14A–15(e) shows geogrids, a heavy lattice of very strong plastic placed in layers in the granular fill used to reconstruct the slope. Figure TS14A–15(f) shows the completed project.

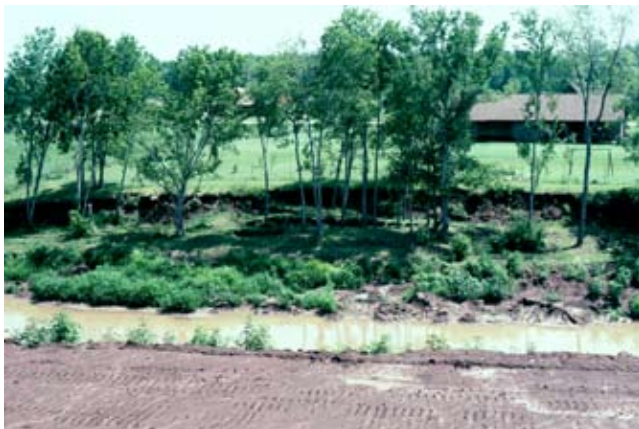
**Figure TS14A-20** Stream slope that failed when the stream was deepened by about 4 feet to increase the flow capacity

Figure TS14A-20 shows a slope failure on a stream-bank that occurred when the stream was deepened about 4 feet to increase the flow capacity and blocky structured clays occurred in the streambanks. Root reinforcement of large trees was inadequate to resist the large forces active in this type of failure. Note that large trees were displaced by the failure.

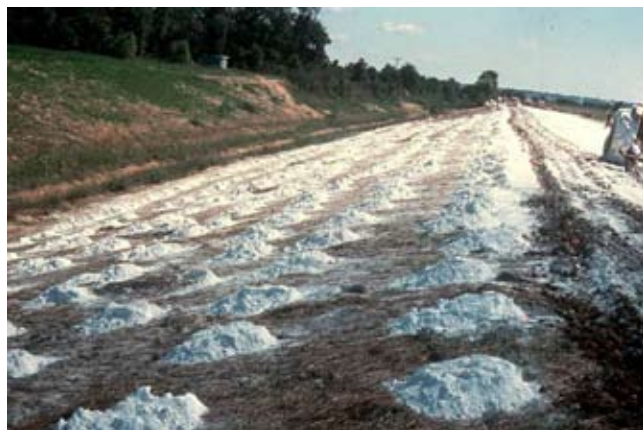
**Figure TS14A-26** A streambank where highly dispersive clays were treated by applying and mixing in hydrated lime to the slope soils

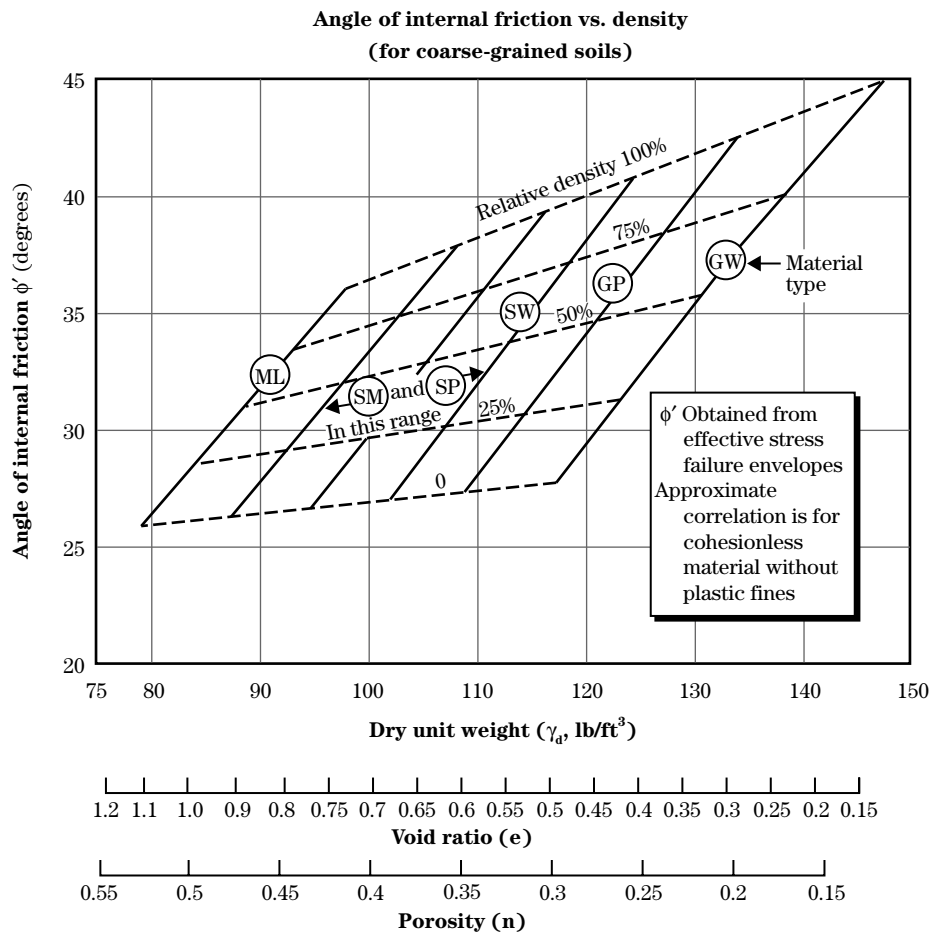
**Figure TS14A-27** An example of a chart used to estimate effective friction angles for different types of soils

**Example:** Assume that the soils in the streambank are loose silty sands. From table TS14A-5, estimate a relative density value of 30 percent. From figure TS14A-27 (NAVFAC 1986), read an effective friction angle for a silty sand with a relative density of 30 percent to be 27.5 degrees.
